## Building Diagnostics: Moisture Testing in Residential Dwellings

Wayne Shellabarger & Joan Gemmill

ACUITY ENGINEERS, INC.

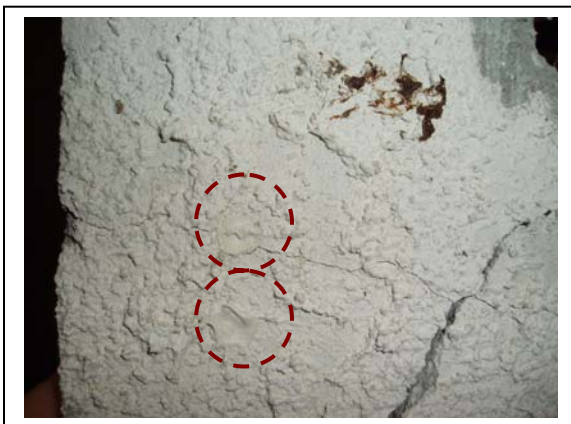
Sealant applied to holes at the stucco subsequent to exterior moisture testing.

Last but certainly not least, a critical reason not to test in this manner is the inability to restore not only the aesthetics of the cladding but more importantly the integrity of the flashings and drainage plane that has now been compromised. In addition, we have found that sealant applied at the open stucco penetrations routinely does not reach the holes made at the drainage plane and if it does, the Expected Useful Life of properly applied exterior grade sealant is approximately seven years with annual monitoring recommended and maintenance as required. Frequently, we have examined stucco clad dwellings that have been tested for moisture utilizing this exterior destructive method and as the stucco is being removed for remediation purposes, we have seldom seen where the sealant has reached the building paper/drainage plane. It has also been our unfortunate experience to witness, based on exterior testing results, unnecessary stucco removal at structures where the sheathing was intact and in sound condition. Again, the practice of exterior moisture testing appears to be common as it is relatively fast with one reading obtained at each test location and therefore inexpensive — up front. Unfortunately, the homeowner just permitted the structure's integrity to be compromised with procuring moisture readings at the outer side of the sheathing, which may be false at that!

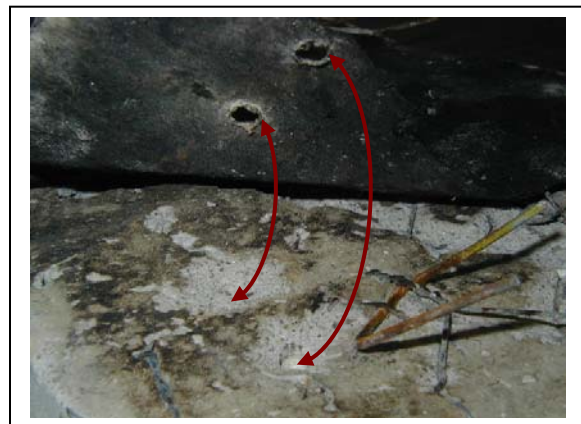
Sealant applied at the stucco subsequent to exterior moisture testing typically does not reach the building paper whereby the drainage plane's integrity is permanently compromised.
